## WATER-WORN LIMESTONE: GARDEN-WALL DECORATION IN LANCASTER

*Michael Haslam*

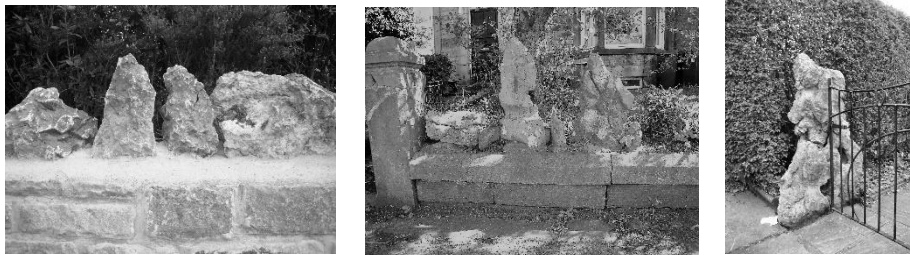
Plates 1a–c Water-worn limestone wall cappings (1a & b) and a gatepost (1c) in Lancaster

occurring horizontally or slightly inclined, that have formed into curious upstanding blocks of water-worn limestone called ‘clints’ that are separated by fissures known as ‘grykes’ (Plates 1a–c). Each block has a unique shape due to water erosion. The nearest lowland limestone pavements to Lancaster are in the Arncliffe and Silverdale area (JNCC, n.d.).

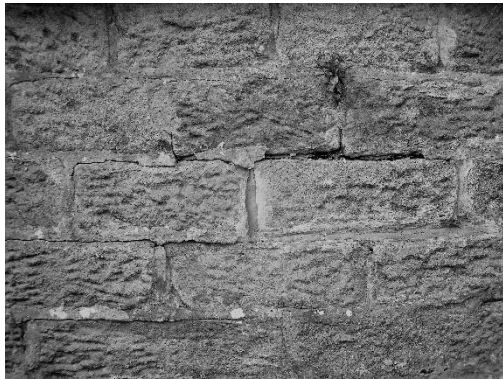
Plate 2a Hammer-dressed

Many stone-faced houses and their front-garden walls in Lancaster were constructed of Namurian Millstone Grit extracted from local quarries to the east or south-east of the town, most notably from Williamson Park, Lancaster Moor, Bowerham, Primrose Hill, Greaves and Freehold (White & Winstanley, 1996). This is a medium- to coarse-grained sandstone that has weathered to take on a colour ranging between yellow, rich brown and dark grey. The sandstone to the front elevation of a house was cut into blocks larger than a modern brick and dressed on the exposed face with one of two types of finish: hammer-dressed and rough-dressed (sometimes referred to as rock-faced) depending upon the age, status and location of the house. It was laid in a regular horizontally coarsed bond (Plates 2a & b).

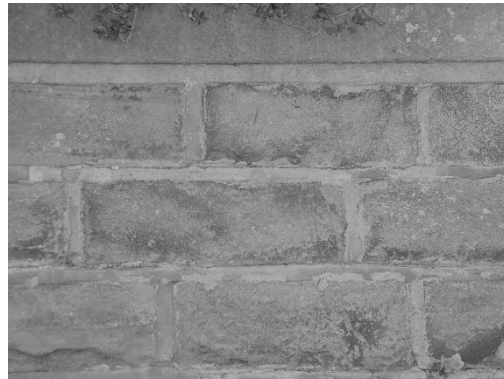
Plate 2b Rough-dressed (or Rock-faced)

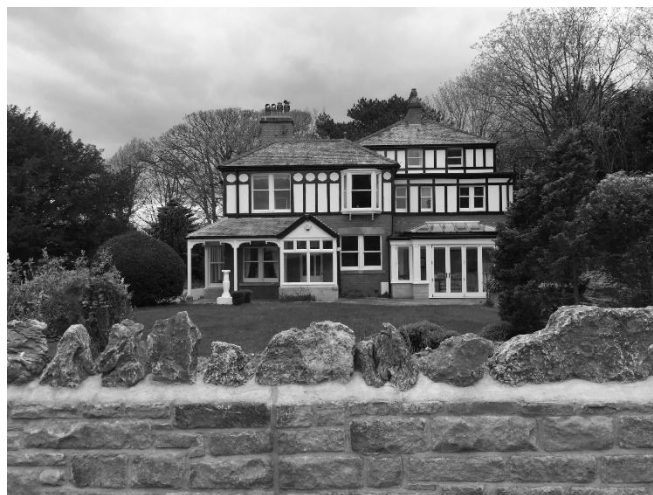
Plate 3 Roxburghe House, Haverbreaks

Particular attention was placed on the high front-boundary wall that borders the road, which is constructed of irregular coursed sandstone with a water-worn limestone capping at eye level. The limestone capping is laid parallel to the linear axis of the wall. There is no sandstone coping on top of the wall and below the limestone capping. The wall gives the notion of security to the house while the limestone capping enhances association with the countryside and the picturesque beauty of the Lake District and the Dales. The entrance to the adjoining house (Tufton Warren) has a similar boundary wall to Roxburghe House but with a flat sandstone coping. Woolerton Dodwell were the landscape designers for Tufton Warren. Woolerton was a pupil in the Mawson practice and it is therefore likely, for reasons that will be explained later, that the sandstone coping to Tufton Warren is an original feature. Whether Roxburghe House also had a sandstone coping that was later removed is not known. Dating limestone-wall capping is often difficult as official records of such decorative changes are scarce.

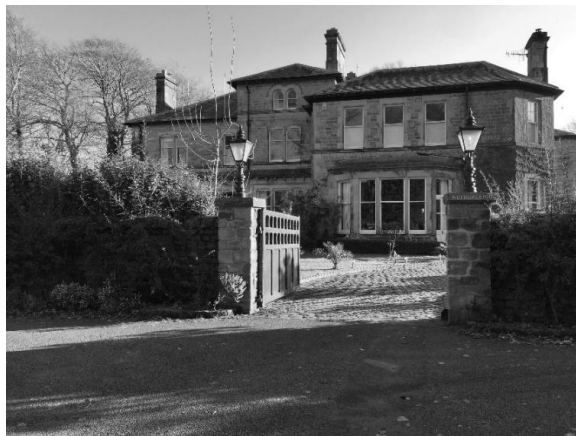
Plate 5 Netherleigh, Westbourne Road

The boundary walls are approximately 2 metres in height and constructed of sandstone blocks surmounted by a triangular sandstone coping stone. The whole garden design, including the boundary wall, is a pleasing link between the landscape and the architecture of the house. Around this time, rock gardens were built for display and were designed to be picturesque, rugged and naturalistic. In his book *The Art and Craft of Garden Making* Mawson said: ‘The water-wash capping is an attempt to beautify a utilitarian feature such as a wall. The wall looks rather like an attempt to imitate natural rock and the whole result is spoiled and the work looks puerile and affected’ (Mawson 1912, 208). Netherleigh does not have water-worn limestone cappings to its walls. Additionally in Waymark’s book on Mawson, whereas stone is widely used for balustrades, terraces, steps and rockeries, not one of the 116 photographs of his gardens in the UK shows water-worn limestone wall cappings (Waymark 2009). It therefore seems unlikely that Mawson would have constructed the boundary wall at Emmanuel House with a water-worn capping. Given these remarks it is reasonable to assume that the limestone water-worn cappings to Roxburghe House and Emmanuel House were not installed until the 1960s.

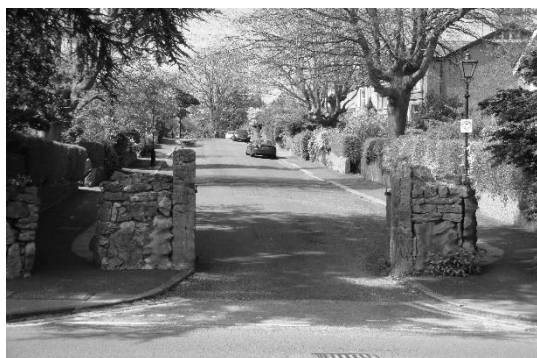
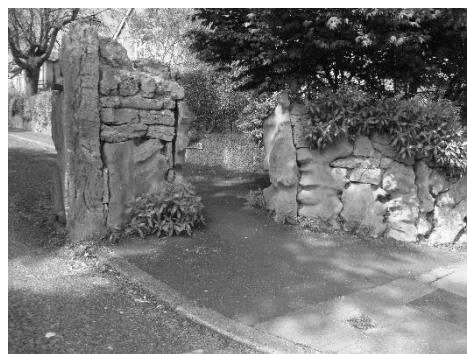
Plates 6a and 6b Entrance to Eden Park, Scotforth

The entrance to Eden Park off Scotforth Road has excellent examples of Cyclopean limestone boulders over 2 metres high and used as gateposts, similar to those at Meadowside but much larger (Plates 6a & b). Several of the Edwardian houses in the cul-de-sac have similar but smaller gateposts. From a visual inspection it appears these stones were installed when the road was constructed and this provides further dating evidence. The first houses on Eden Park were approved between 1910 and 1915, the developer again being R. Baines.

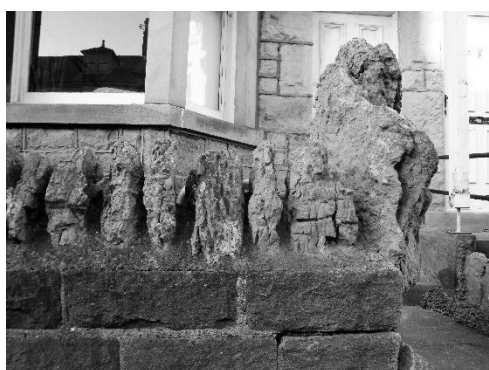
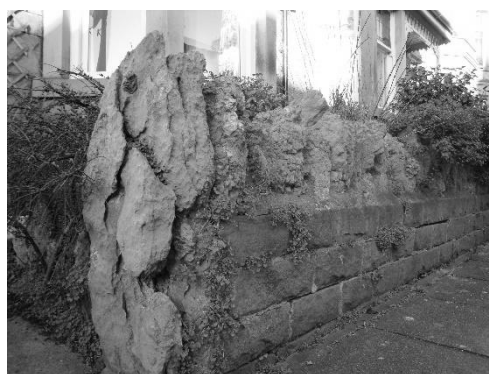
Plates 7a and 7b Redvers Street, off Westbourne Road

There are four Edwardian three-storey terraced houses built c.1905 at the south-west end of Redvers Street with unique front-garden walls. The houses have ground-floor bay windows and very small front gardens and are similar to other local houses but of a more modest design and in a different setting to the houses in Meadowside and Eden Park. Each of the four houses have Cyclopean boulder-stone gateposts with sandstone boundary walls between them that are surmounted by water-worn-limestone capping stones that have been laid at *right-angles to the linear axis of the walls*, the only example of this Lancaster (Plates 7a & b). This alignment is in keeping with the limestone walls and cappings to houses and farms in the Lake District. There is no evidence for the presence of water-worn limestone cappings laid *parallel to the main axis of the garden wall* in residential areas in Lancaster until after the Second World War. The existence of Cyclopean boulder gateposts to all four houses and the lack of any original sandstone copings under the limestone cappings support the view that the gateposts and limestone cappings were built with the houses around 1905.

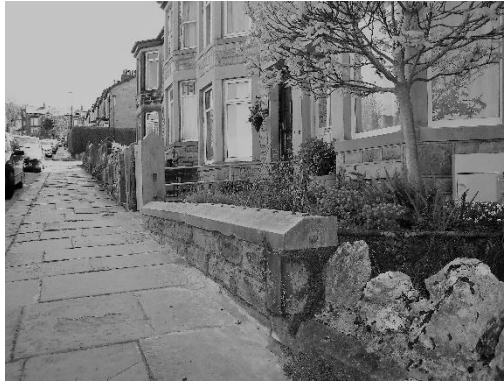
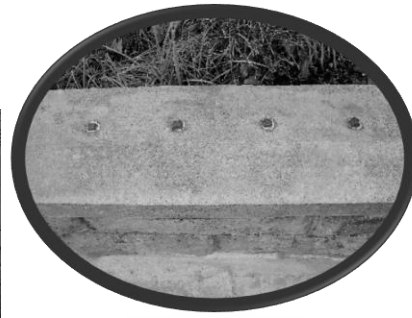
Plate 8 Evidence of railings having been removed

In the early 1940s the Government ordered all post-1850 iron railings in parks, outside offices and at residential homes to be removed and melted down for the war effort under Regulation 50 of the Defence (General) Regulations 1939. This was intended to be a unifying act for the country and of propaganda value. Wrought-iron railings to front-garden walls outside the town centre were very common in Lancaster and there is still widespread evidence of these former garden-wall railings. It is easy to see the cut ends of the top and bottom horizontal rails of the railings where they had been built into the gateposts (Plates 8 & 9).

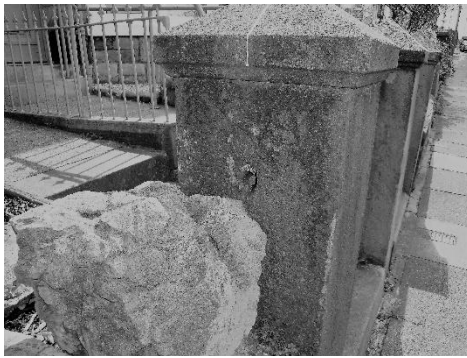
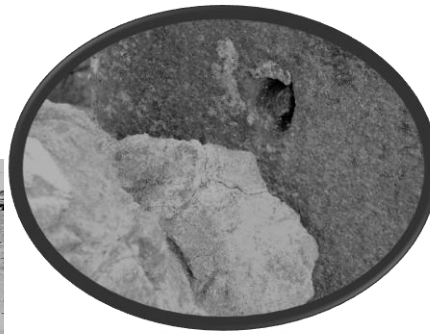
Plate 9 Evidence of limestone cappings having been installed after the railings had been removed

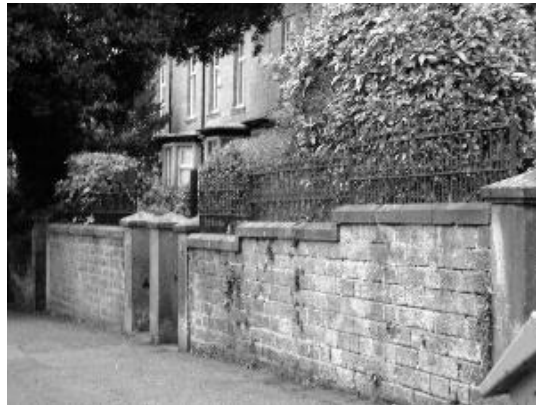
Plate 10a Belle View Terrace, Greaves, c.1891

A sandstone wall with sandstone coping to No. 35. The railings are original. Nos 37–53 are similar but the walls are higher and have retained their original railings.

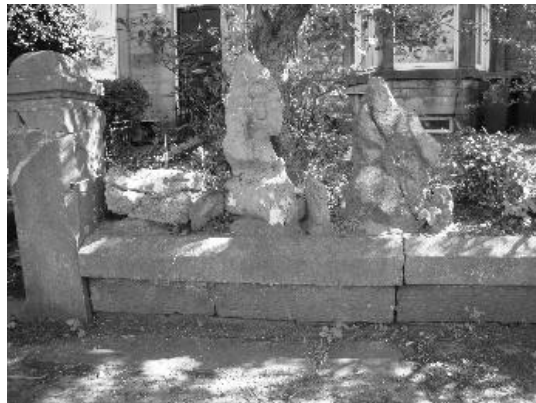
Plate 10b Belle Vue Terrace, Greaves c.1850

A low sandstone wall with a sandstone coping. A limestone water-worn capping has been added sometime after the railings were removed to Nos. 3, 9, 21 and 23.

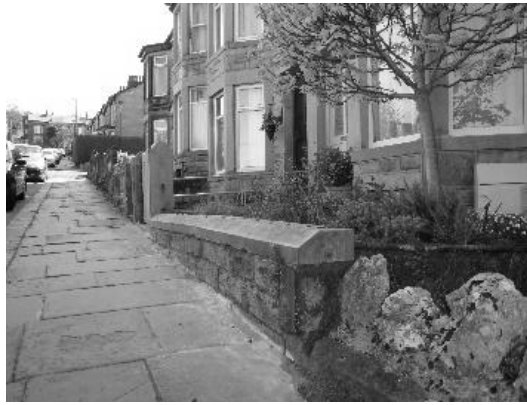
Plate 10c Bridge Road, Greaves c.1901

A typical original front wall with detail in sandstone. Note the end view of the sandstone coping: the inner face vertical, the outer face cut to a slope. There would have been railings on the flat top of the coping. The adjoining house has identical detail but a limestone capping has been added.

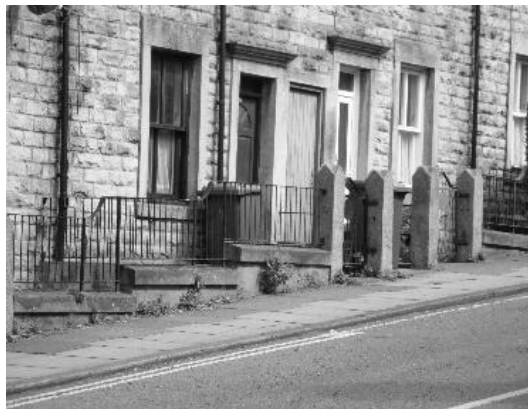
Plate 10d Primrose Street, Primrose, c.1880

The original railings have been removed and later replaced. The replacements are bolted to the gate posts whereas the ends of the horizontal top and bottom rails of the original railings were set into holes in the gateposts and secured with molten lead. See Plates 8 and 9 for an enlarged view.

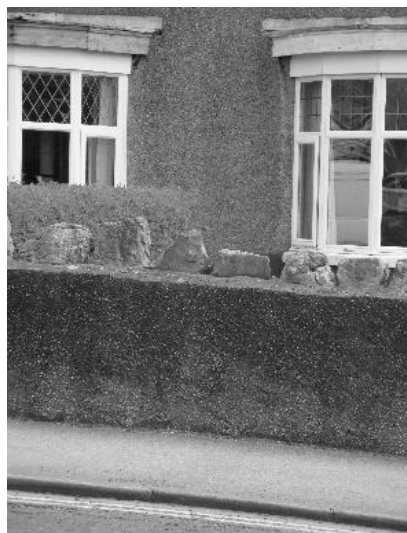
Plate 10e Bowerham Road c.1930

A brick boundary wall rendered on both sides and carried over the top. The water-worn limestone capping was added sometime after the wall was built.

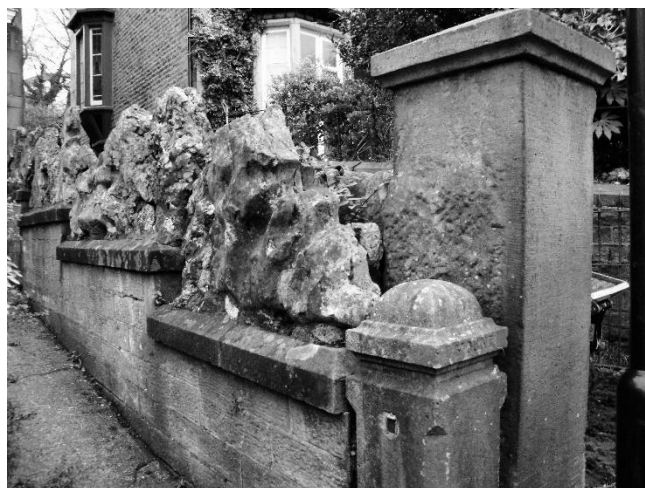
Plate 10f Belle Vue Terrace, Greaves c.1893

The large water-worn limestone capping has been added later to the original sandstone coping.
